# **TALLAHASSEE MASTER PLAN – SURFACE WATER (TMaPS): VOLUME 3**

## **LAKE MUNSON BASIN**

Project Number: FW7714

July 2025

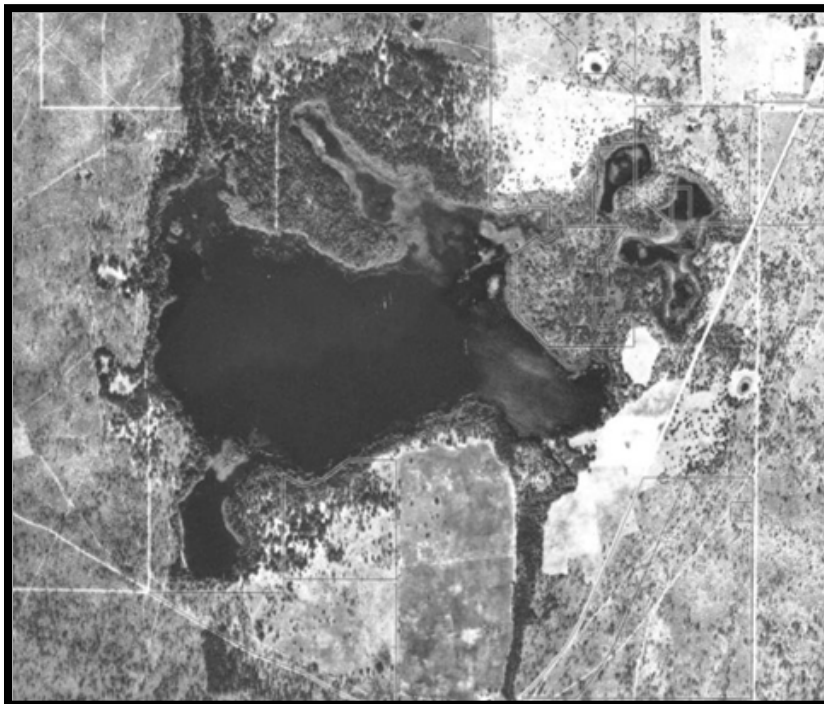
**Photo 3-1: Lake Munson Aerial – 1937**

In more recent times, a modern dam control structure was constructed to replace the 1950s dam. **Photo 3-1** through **Photo 3-8** present aerial photographs of Lake Munson from 1937 through 2020. The photos show that overall, the lake has retained its general shape and open water area. The introduction of the dam in the 1950s appears to create a larger permanent pool area than is seen in the 1930s photo. **Photo 3-9** and **Photo 3-10** show the lake and the control structure respectively in 2021. Lake Munson discharges to lower Munson Slough, Eight Mile Pond, and Ames Sink. Recharge from Ames Sink emerges at Wakulla Spring and flows to the Gulf of Mexico. Dye trace studies have confirmed a direct connection between Ames Sink and Wakulla Spring (Stevenson, 2016).

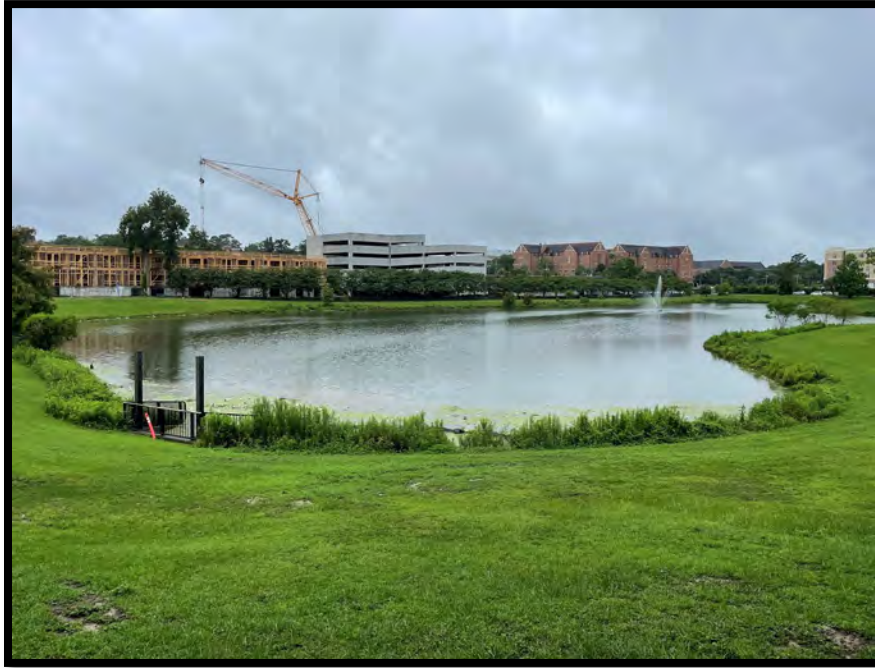
**Photo 3-11: Carter-Howell-Strong Wet Detention Pond**

Due to its highly urbanized nature, the Central Drainage Ditch, and the historic St. Augustine Branch which flows into the Central Ditch, contain a number of larger regional facilities. The Carter-Howell-Strong Pond (**Photo 3-11**), located in the upper end of the Central Ditch is a 5-acre wet detention facility that receives drainage from portions of FSU and surrounding residential areas. Lake Elberta (**Photo 3-12**) is a 17-acre wet detention facility at the confluence of the Central and St. Augustine Branch. A series of treatment facilities is located along the historic St. Augustine Branch. These include the Cascade Park stormwater treatment facilities

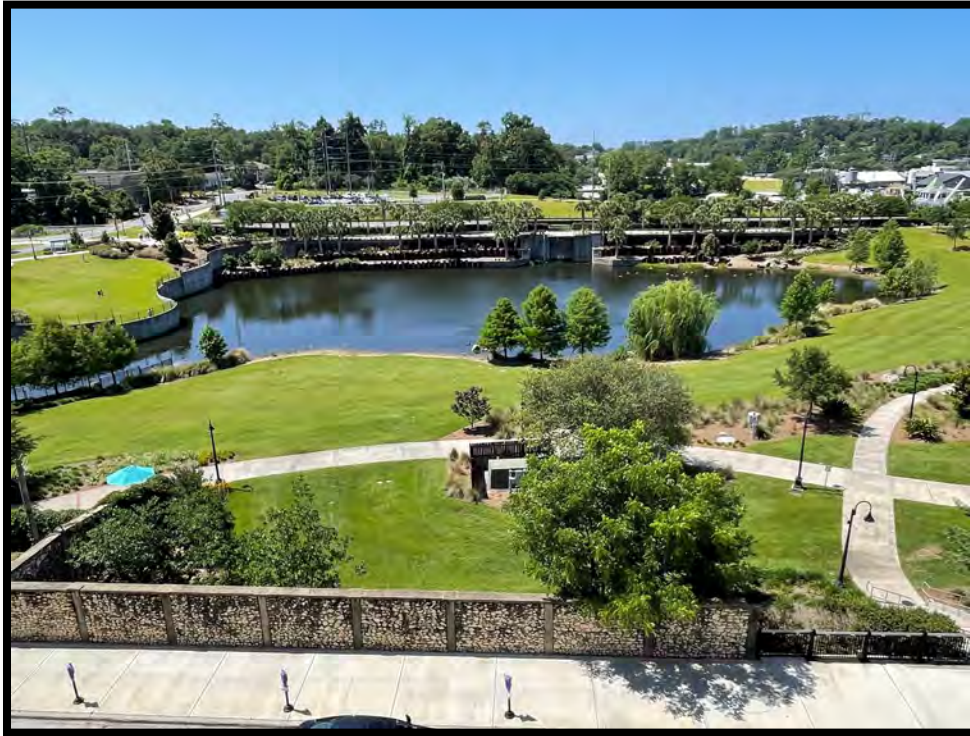
**Photo 3-13: Boca Chuba Wet Detention Pond in Cascade Park**

including two wet detention ponds (1 acre and 2 acre) and other treatment components (**Photo 3-13**), Lake Anita (**Photo 3-14**) a 2-acre wet detention facility along FAMU Way, and a 1.2-acre wet pond near Railroad Square Park (**Photo 3-15**).

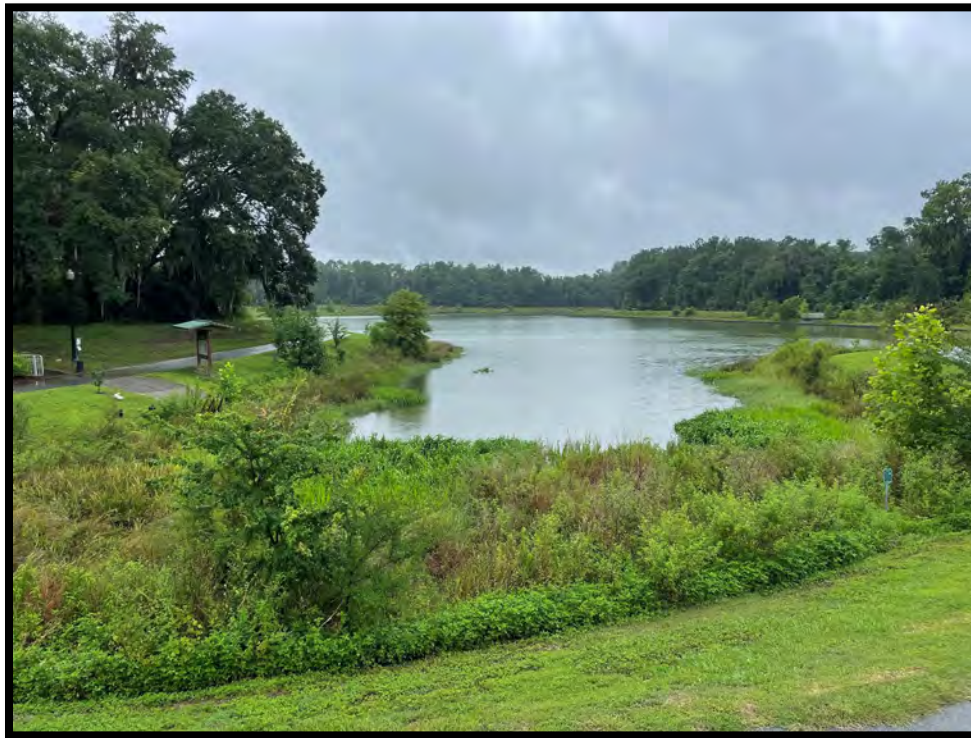
**Photo 3-16: Martha Wellman Wet Detention Pond**

Treatment facilities within the West Drainage Ditch are generally smaller stormwater treatment facilities constructed to support land development and are maintained by the City and the Florida Department of Transportation (FDOT). Numerous FDOT-maintained facilities are located around I-10 and Capital Circle in the upper portions of the West Drainage Ditch. One larger facility, maintained by Leon County, is Martha Wellman Pond, a 13-acre wet pond near the intersection of Capital Circle SW and West Tennessee (**Photo 3-16**).

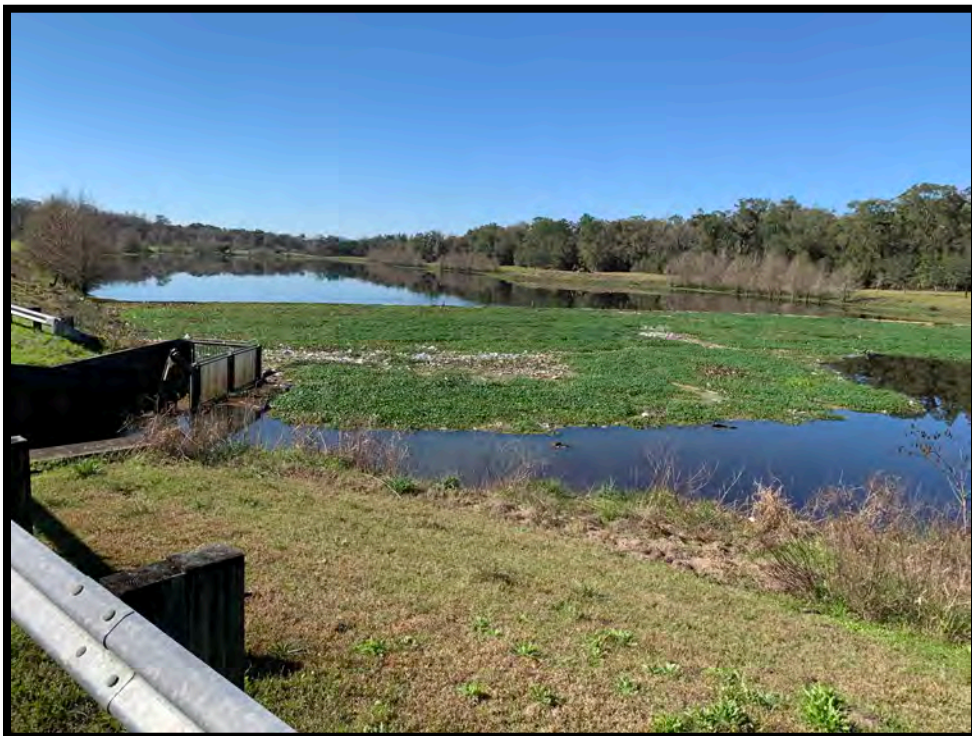
**Photo 3-18: Lake Henrietta SWMF Regional Treatment Pond, Middle and South Sections Facing South**

The largest stormwater facility within the Lake Munson basin is the Lake Henrietta SWMF, which was constructed in 2000 and is located at the confluence of Munson Slough and the East Drainage Ditch. Lake Henrietta was historically a wetland system that was altered through the construction of a mosquito control ditch and berm, and ongoing sedimentation and pollutant discharge from Munson Slough. As part of the Leon County Lake Munson restoration, the altered wetland system was converted to a 25-acre wet detention treatment facility with trash traps to reduce sediments, slow runoff, and reduce trash before water enters the restored and stabilized channel north of Lake Munson (**Photo 3-17** and **Photo 3-18**).

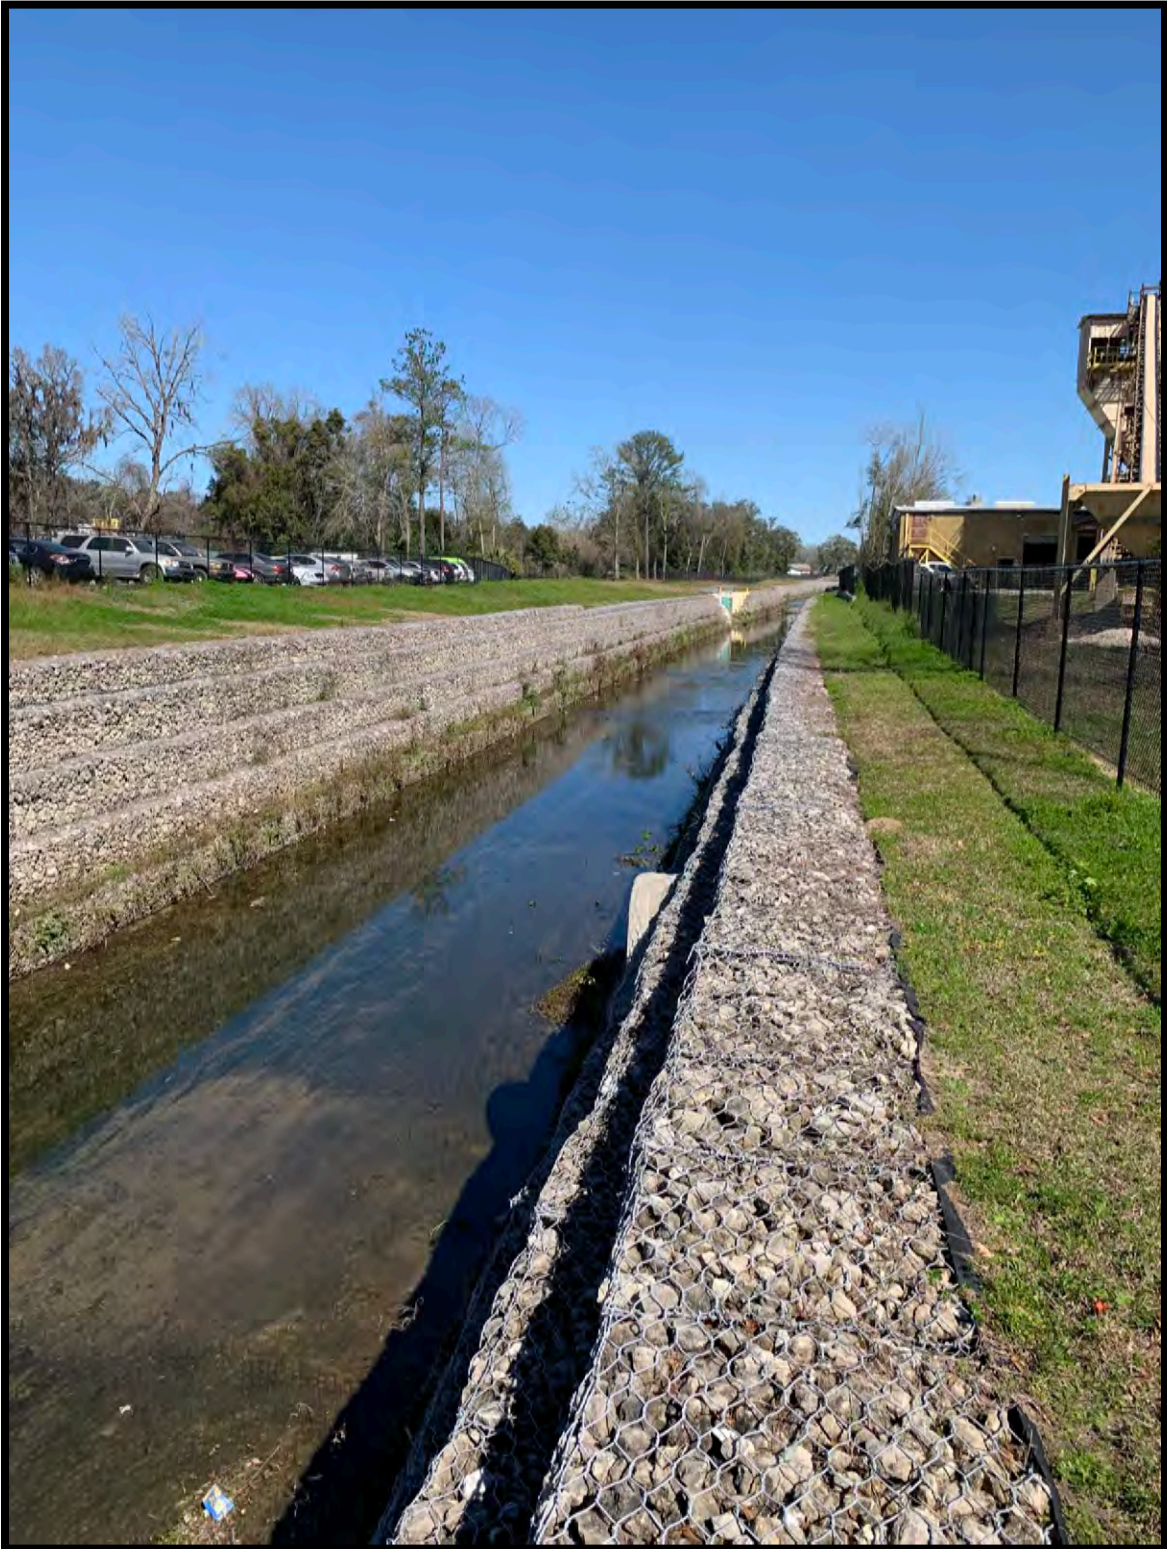
**Photo 3-19: Channel Stabilization Project along Central Ditch**

In addition to treatment facilities, projects have been constructed to stabilize channels to reduce erosion and the transport of sediments to downstream waterbodies. **Photo 3-19** shows a bank stabilization project along the Central Drainage Ditch. Ongoing erosion issues still exist at various locations throughout the drainage system. **Photo 3-20** shows a portion of the Central Drainage Ditch along Eppes Drive where bank erosion can be seen.

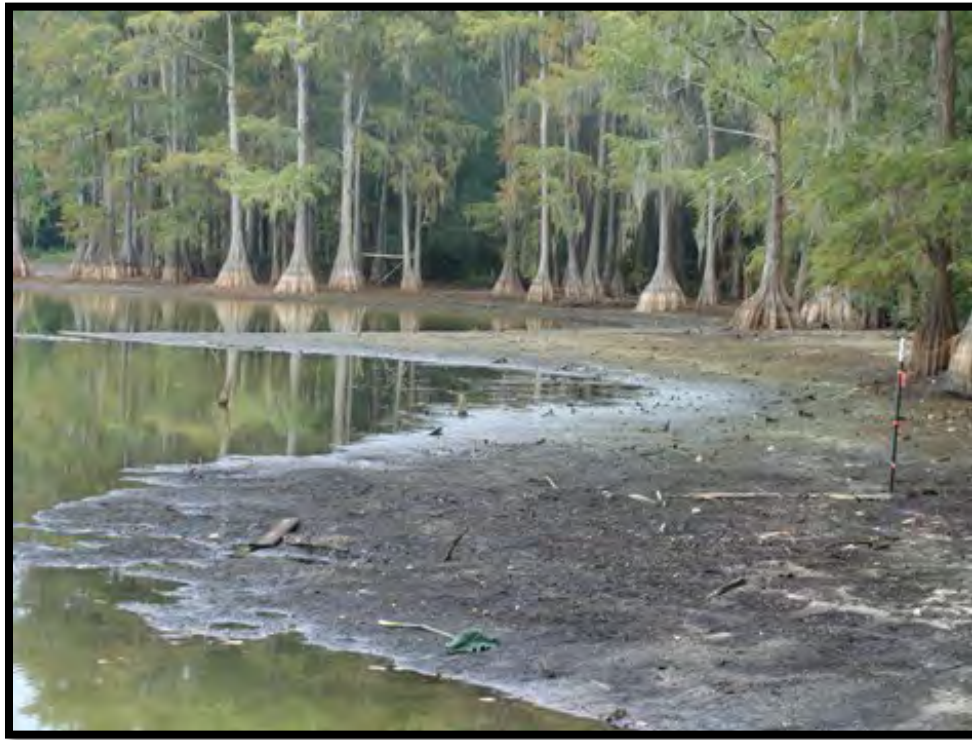
**Photo 3-21: Lake Munson during Drawdown (2011)**

To date, the main activities completed to address in-lake loads have been periodic drawdowns for the purpose of oxidizing and consolidating the sediments and reducing long-term fluxes. Drawdowns occurred in 1977 and 2010. The 2010 drawdown commenced on October 18, 2010, and continued until June 14, 2011 (**Photo 3-21**).

A 2014 Florida Department of Environmental Protection (FDEP) sediment biogeochemical study to quantify temporal and spatial changes in nutrient characteristics of the lake sediments in response to the 2010 drawdown indicated that significant removal of TN occurred but TP removal was not as significant (FDEP, 2014). The study identified that a combination of planting and harvesting could maximize TN and TP removal from the exposed lake sediments through proper management of the drawdown.

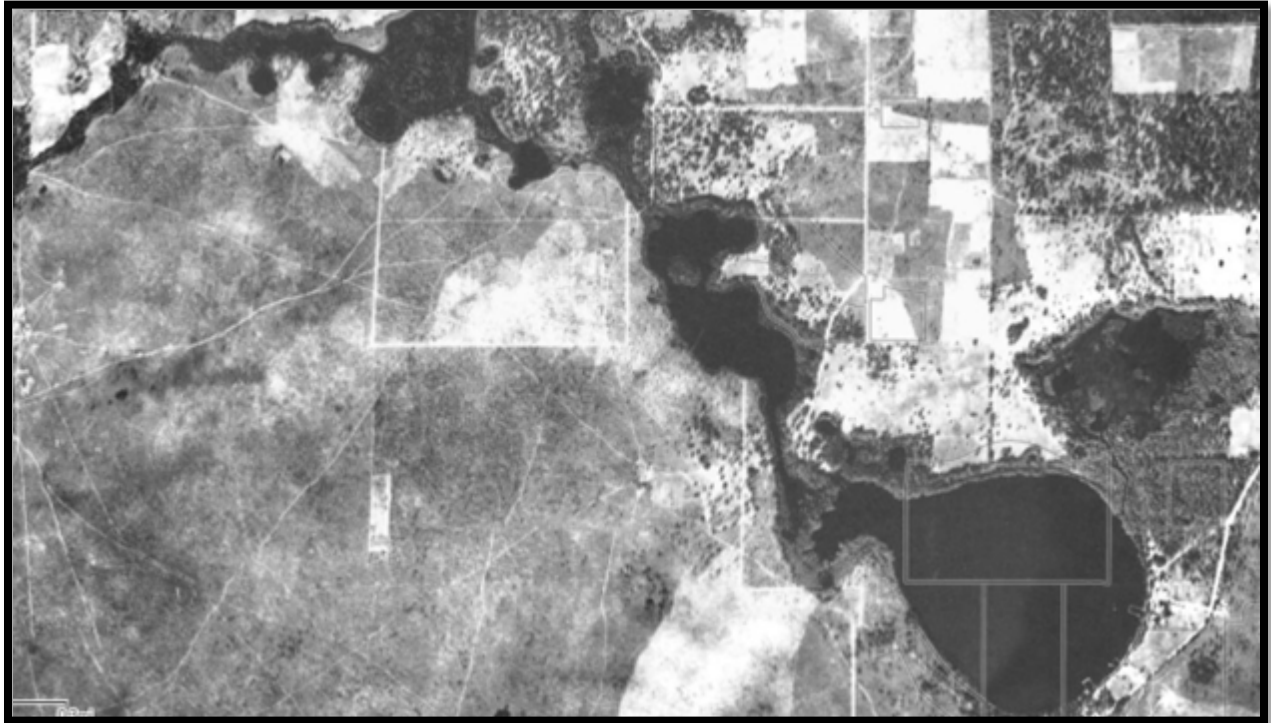
**Photo 3-22: Bradford Chain of Lakes Aerial (1937)**

**Photo 3-22** through **Photo 3-29** present aerial views of the lakes from 1937 through the present. Examination of the aerial photos shows that, overall, the structure of the chain of lakes has not changed significantly since 1937. The aerials show that the area of water changes over time, likely with dry versus wet conditions, especially in the upper reaches around Cascade Lake. Also observable is the conversion of prairie land to silviculture and then to protected forest, increases in nearby development, and the construction of Capital Circle and the airport, which first appear in the 1970 aerial (**Photo 3-22**).

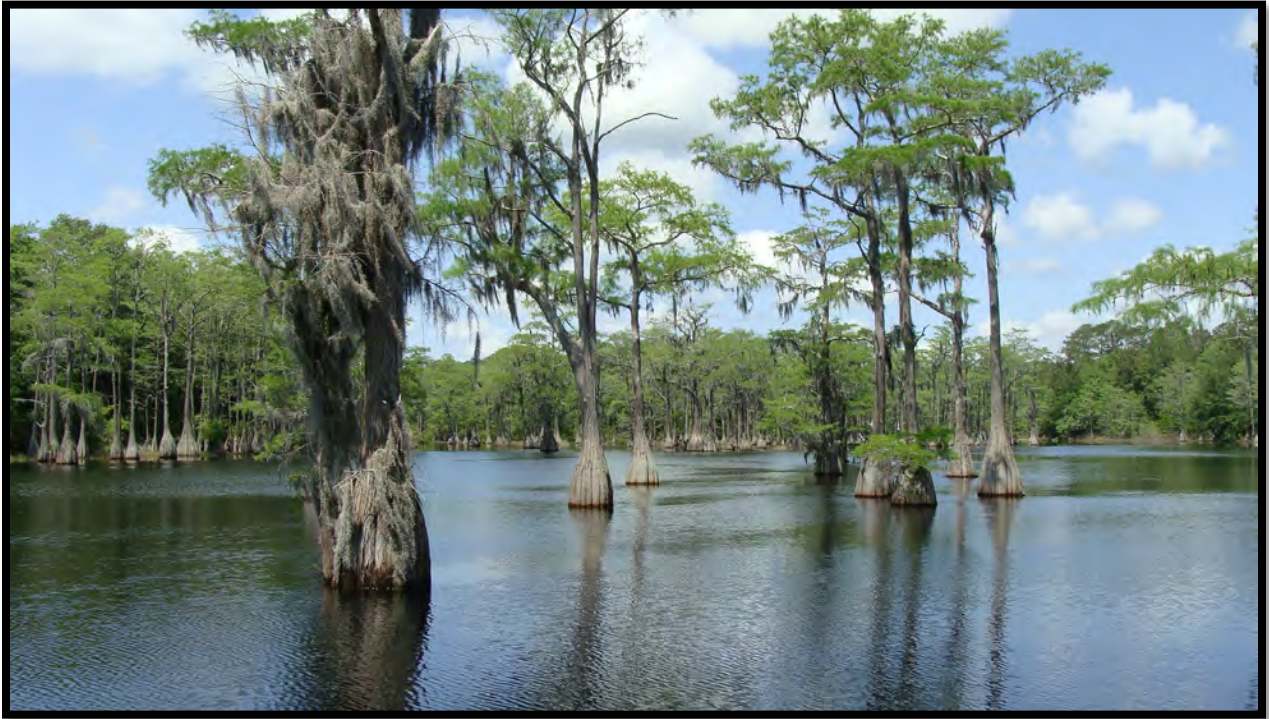
**Photo 3-30: Northeast Side of Lake Bradford (2013)**

Lake Bradford is a 149-acre high color lake and is the largest waterbody in the chain of lakes. **Photo 3-30** shows the northeast end of the lake. The bulk of the lake inflow is from Lake Hiawatha, which then flows through the lake and out to Grassy Lake. At times of significant rainfall, such as under storm events of 5-year return frequency or greater, flow historically reversed and flowed from Grassy Lake into Lake Bradford across Lakeview Drive. Under some conditions, backflow would also enter Lake Hiawatha (Leon County, 2019; City, 2019). Following a 2014 study, Lakeview Drive was elevated, piped conveyance was increased, and the outflow structure from Lake Bradford was updated by increasing the weir elevation and including a one-way valve to prevent backflow. **Photo 3-31** shows the present structure at the connection between Lake Bradford and Grassy Lake. The check valve can be seen in the photo. While the one-way valve prevents backflow from Grassy Lake to Lake Bradford under frequently occurring storm events, larger, less frequent storm events still have the potential to generate backflow from Grassy Lake when downstream water levels exceed the elevation of the weir. Even with the known backflow issues, Lake Bradford has been a healthy, well-balanced lake throughout its history. A recent issue within the lake is elevated lead levels, which is discussed in more detail in **Section 3.5.2**.
