# **TALLAHASSEE MASTER PLAN – SURFACE WATER (TMaPS): VOLUME 4**

**LAKE JACKSON BASIN**

**July 2025**

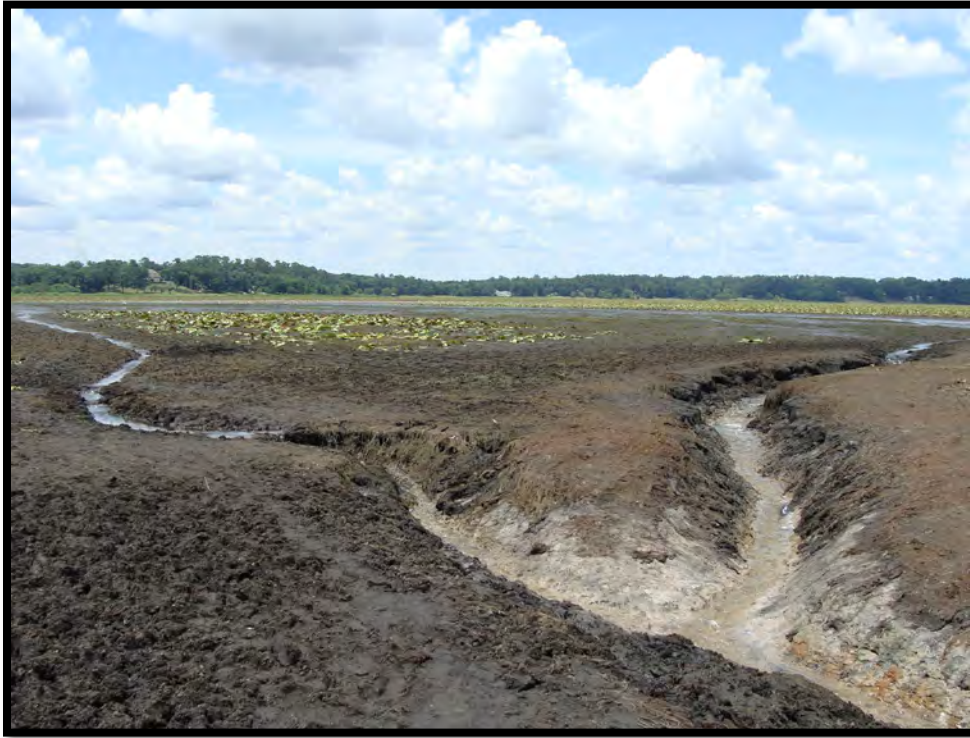
**Photo 4-1: Flows Draining from Lake Jackson to Porter Sink (June 14, 2021)**

**Photo 4-1** shows the flow entering the area of the Porter Sink from the lake as it drains. **Photo 4-2** shows the Porter sinkhole and the flow moving into the aquifer.

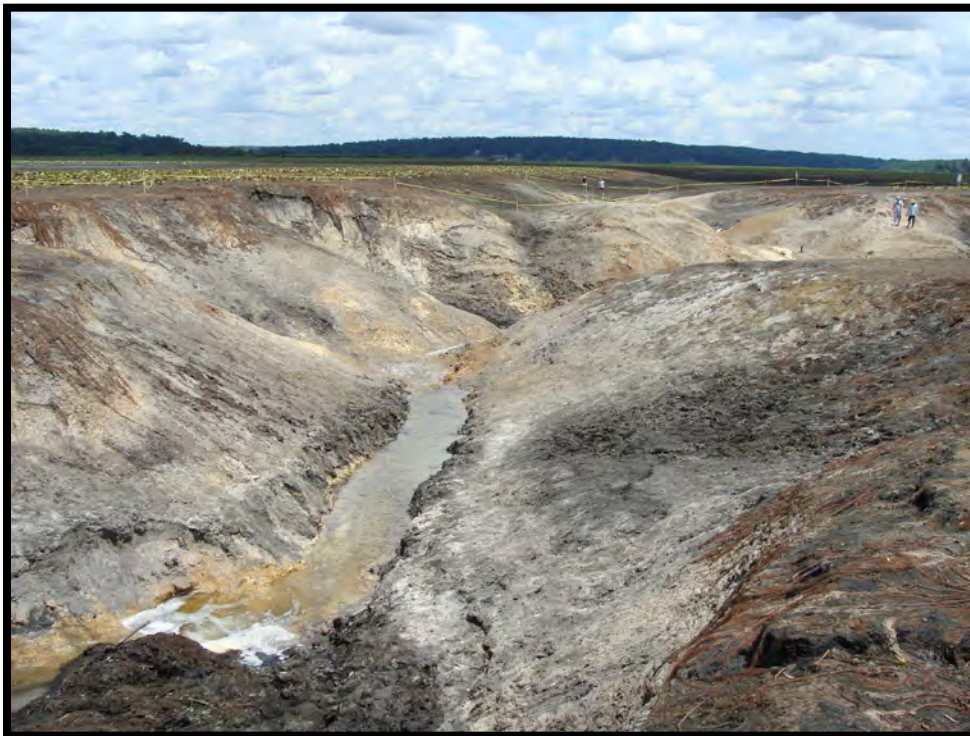
**Photo 4-2: Flows Going to Floridan Aquifer through Porter Sink (June 14, 2021)**

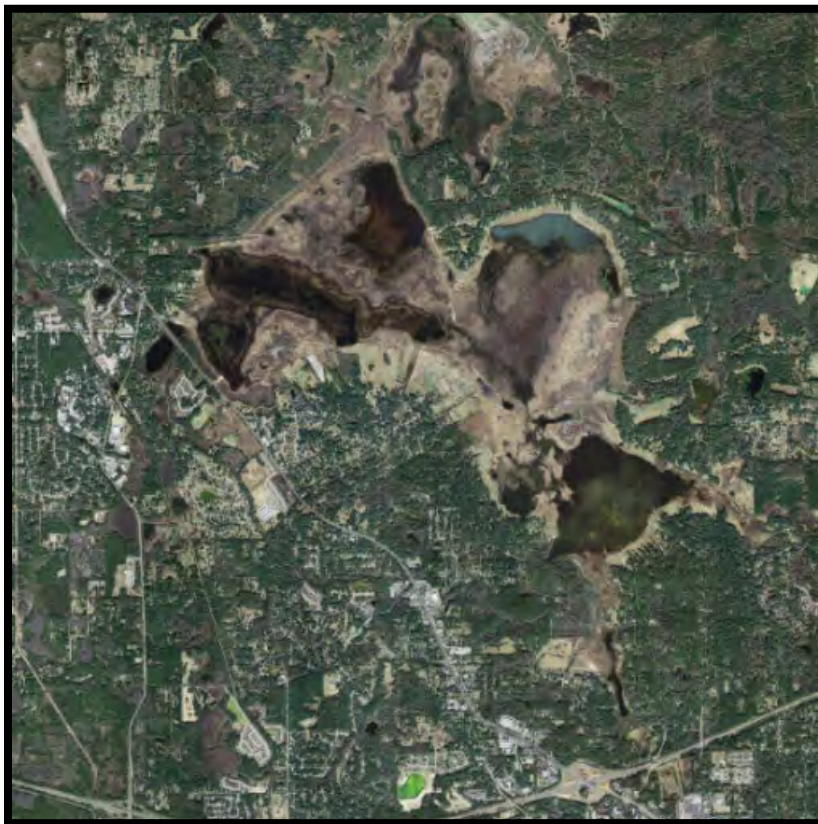
**Photo 4-9: Lake Jackson Aerial – 2007**

Since 1900, the lake has had 11 documented “dry down” events; these occurred in 1907, 1909, 1932, 1935, 1936, 1957, 1982, 1999-2000, 2006-2007, 2012 and 2021. **Photo 4-3** through **Photo 4-10** present aerial views of the lake from 1937 through the present, including the dry down events in the 1930s and mid-2000s.

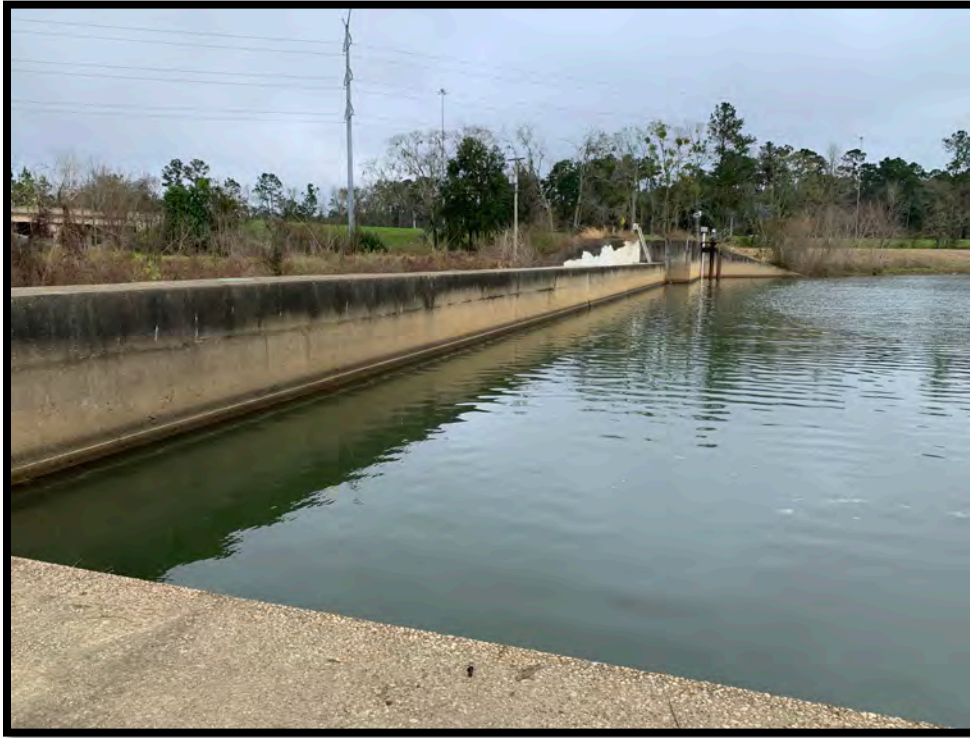
**Photo 4-13: MARS Facility Impoundment and Overflow (February 2021)**

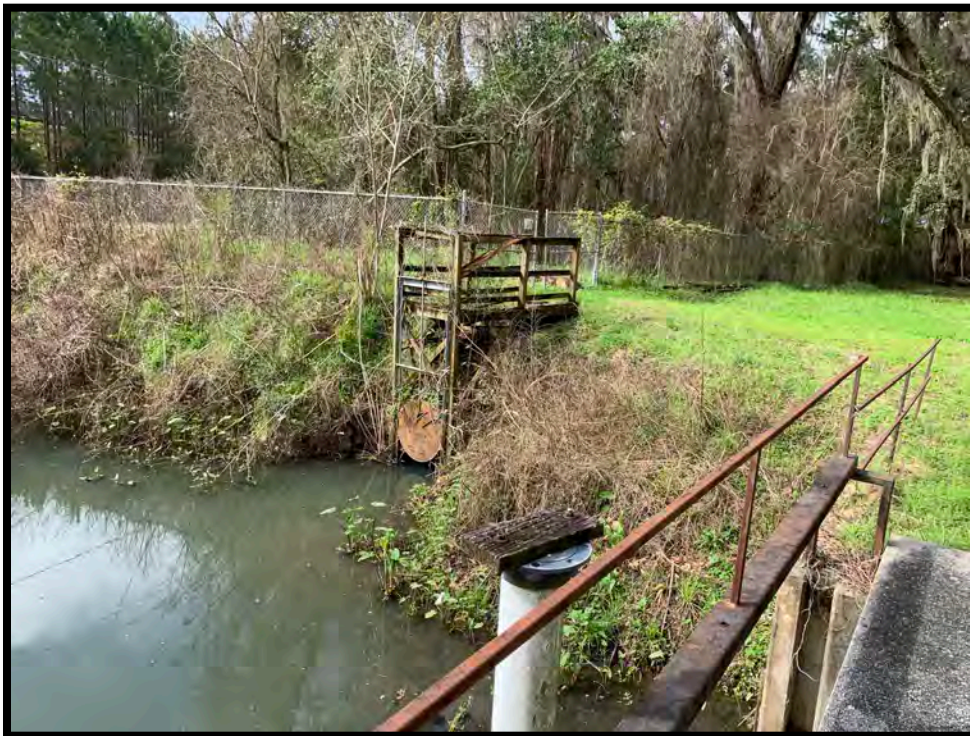
**Photo 4-14: MARS Filter Marsh Intake (February 2021)**

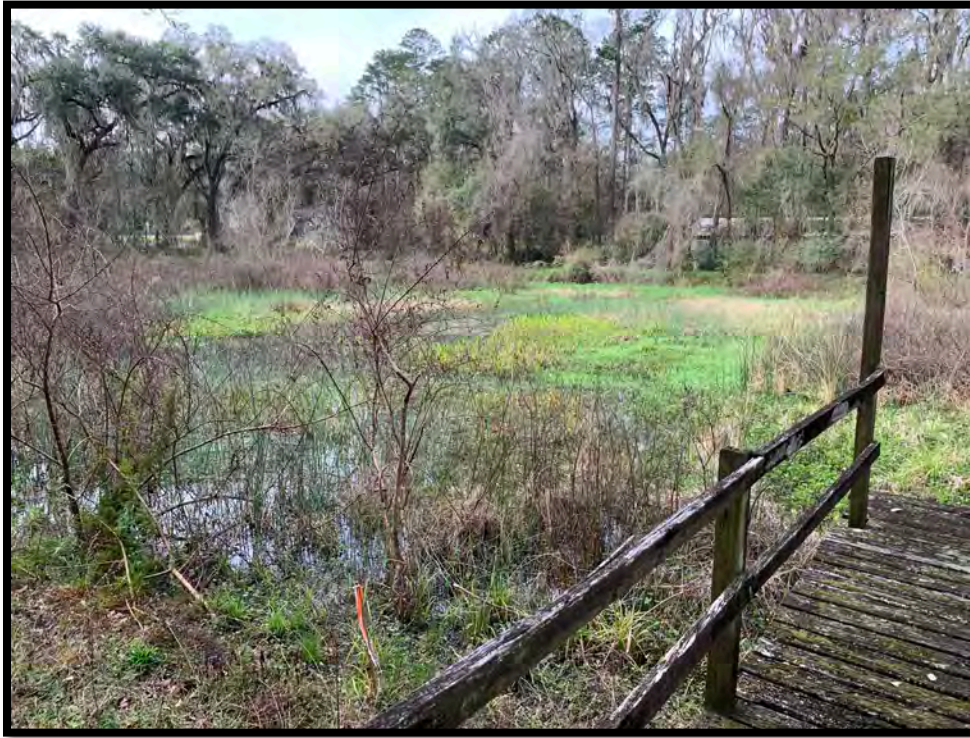
**Photo 4-15: MARS Filter Marsh (February 2021)**

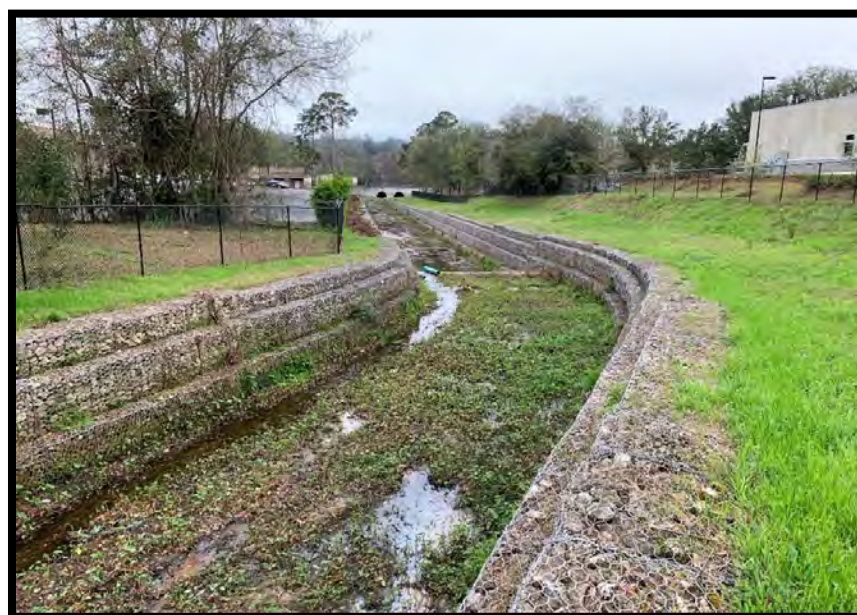
**Photo 4-17: Bank Stabilization Along Megginis Creek**

Other regional stormwater facility construction and retrofit projects in the impacted watersheds include Yorktown Pond, Boone Boulevard Pond, Okeeheepkee Prairie Regional Stormwater Facility, Harbinwood Estates Pond, Sharer Road pond, Abbigail Drive pond, the John Knox Stormwater Management Facility, and most recently, the Lexington Creek Facility. **Photo 4-16** shows the Boone Boulevard Pond. In addition to the various stormwater treatment facilities, several large projects were undertaken to stabilize conveyance systems to the lake that contributed to sediment loading due to erosion. **Photo 4-17** shows the stabilization along Megginnis Creek upstream of the MARS Facility.

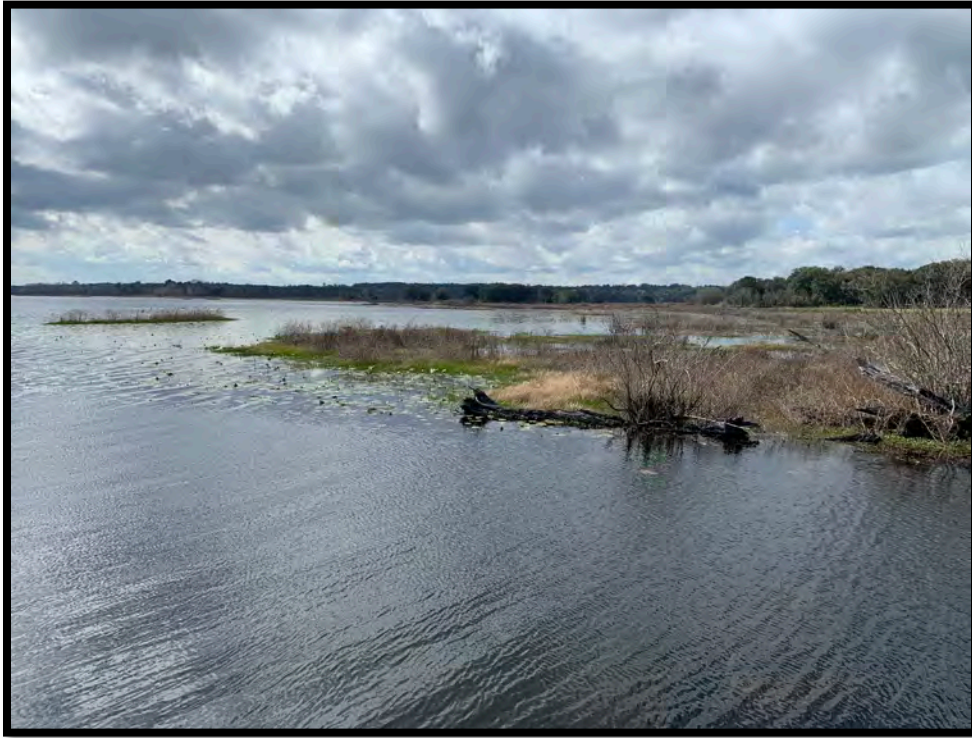
**Photo 4-18: Carr Lake from Boat Ramp (February 2021)**

Carr Lake presently supports a number of recreational activities including kayaking, air boating, fishing, and duck hunting and can support some motorboat activities in the open water area along the northern side where the public boat ramp is located. Due to vegetative cover, much of the lake is only accessible using airboats and through pathways cut through the vegetation that interconnect other smaller open water areas. **Photo 4-18** and **Photo 4-19** show the open water areas and nearshore vegetation from the boat ramp along the northern end.

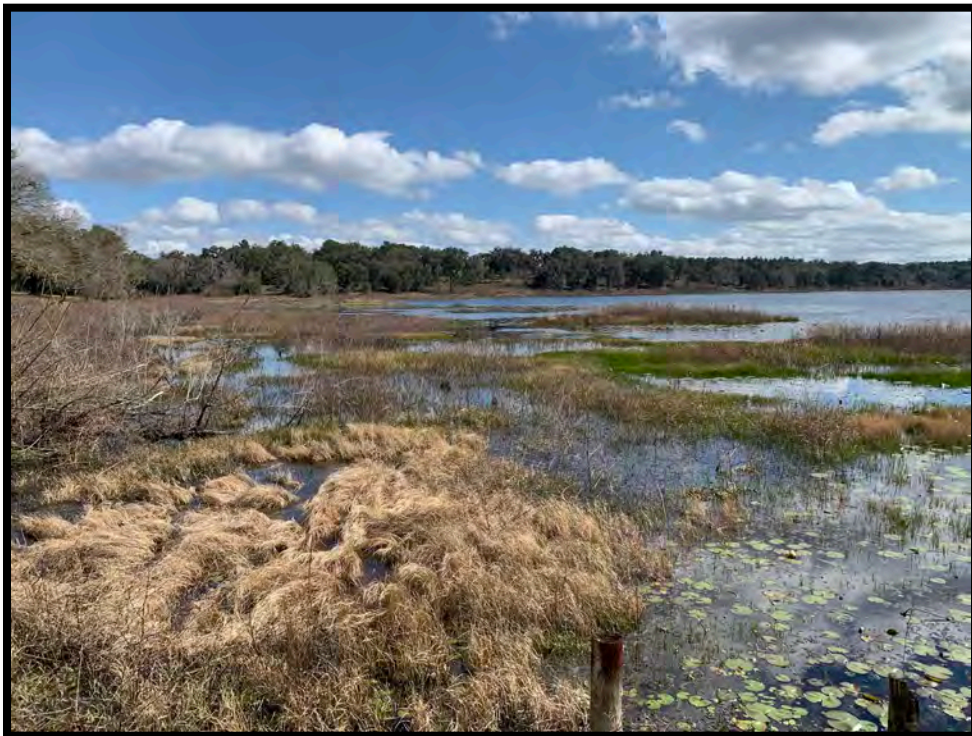
**Photo 4-19: Carr Lake from Boat Ramp (February 2021)**

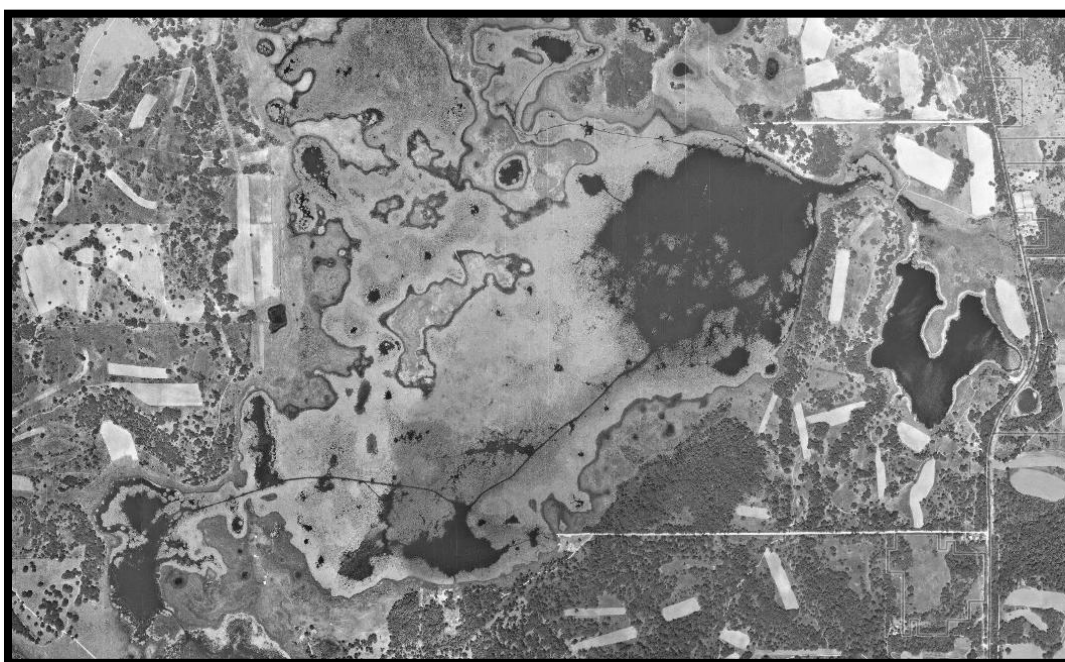
**Photo 4-23: Carr Lake Basin Area Aerial (1970)**

**Photo 4-20** through **Photo 4-27** present aerial views of the lake from 1937 through the present. Examination of the aerial photos shows that the areas of open water have expanded and contracted through time. In the 1937 aerial photo (**Photo 4-20**), the open water areas are of a similar size and nature to those seen in the 2020 aerial (**Photo 4-27**). Through the remaining aerials, the open water areas appear to expand in size, with the largest appearing to be in the 1970 aerial (**Photo 4-23**) and then, subsequently, decreasing in size up to the present.

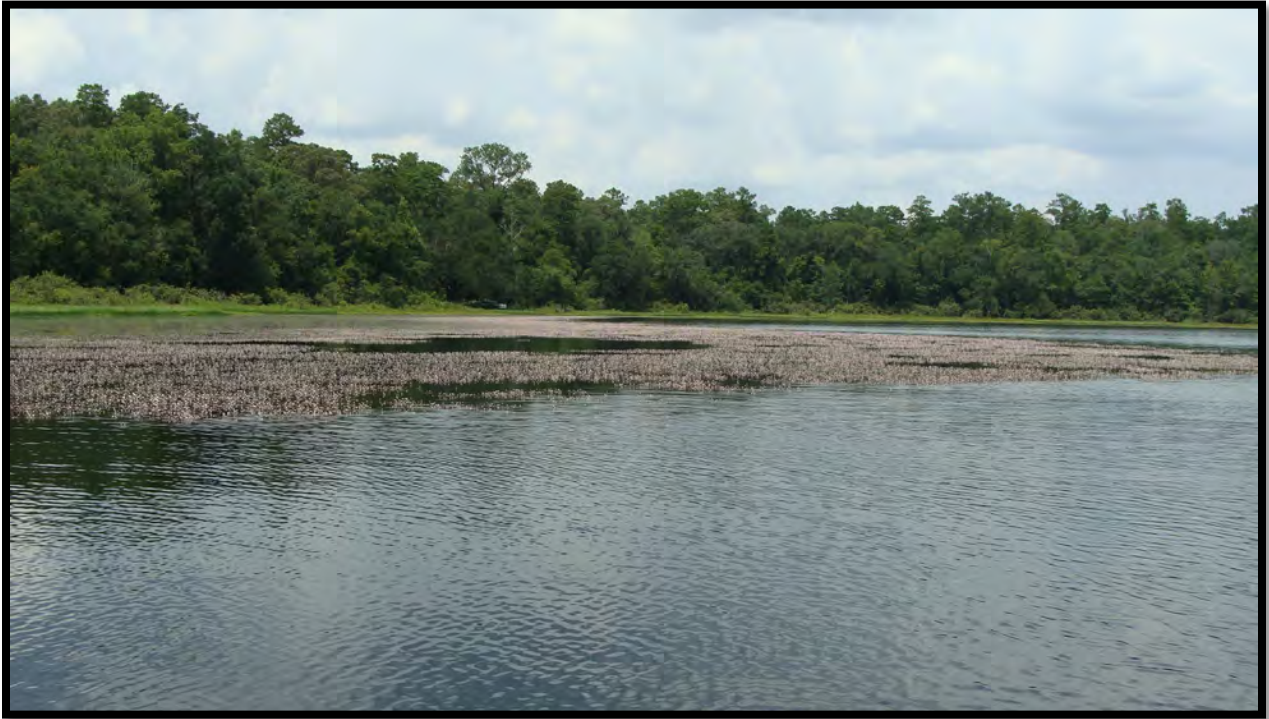
**Photo 4-40: Lake Overstreet (2011)**

Lake Overstreet is a 144-acre pristine natural lake located on the property of Alfred B Maclay Gardens State Park. The lake maintains its natural condition primarily due to limited access and prohibitions on boating and fishing. The lake is only accessible by hiking trails that start within Maclay Gardens State Park and off Meridian Road. **Photo 4-40** and **Photo 4-41** were taken in 2011 and 2012, respectively.

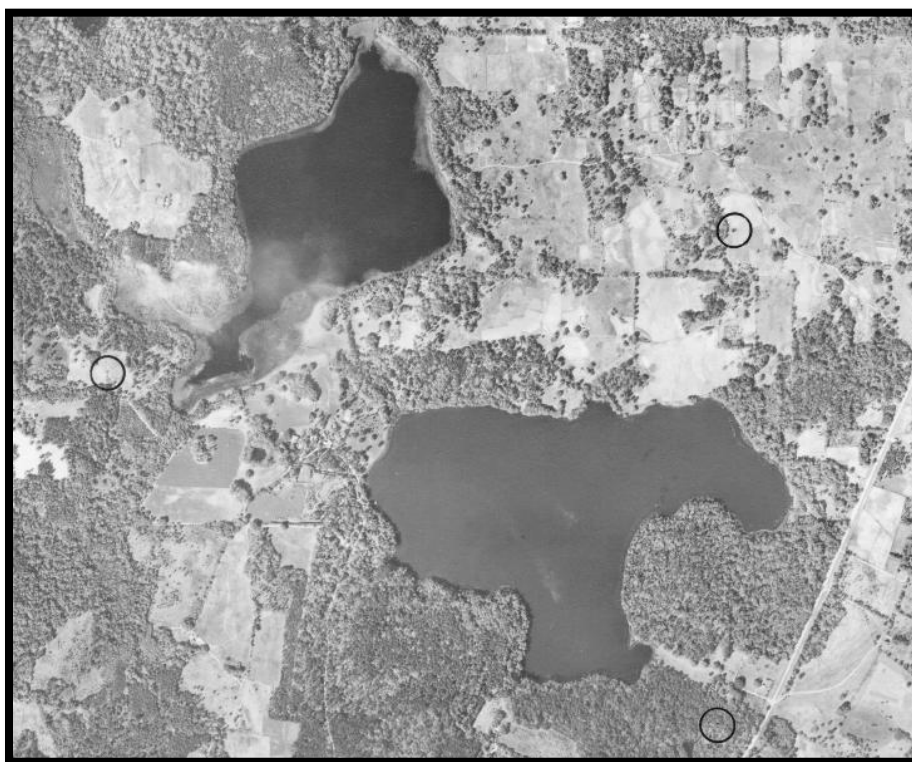
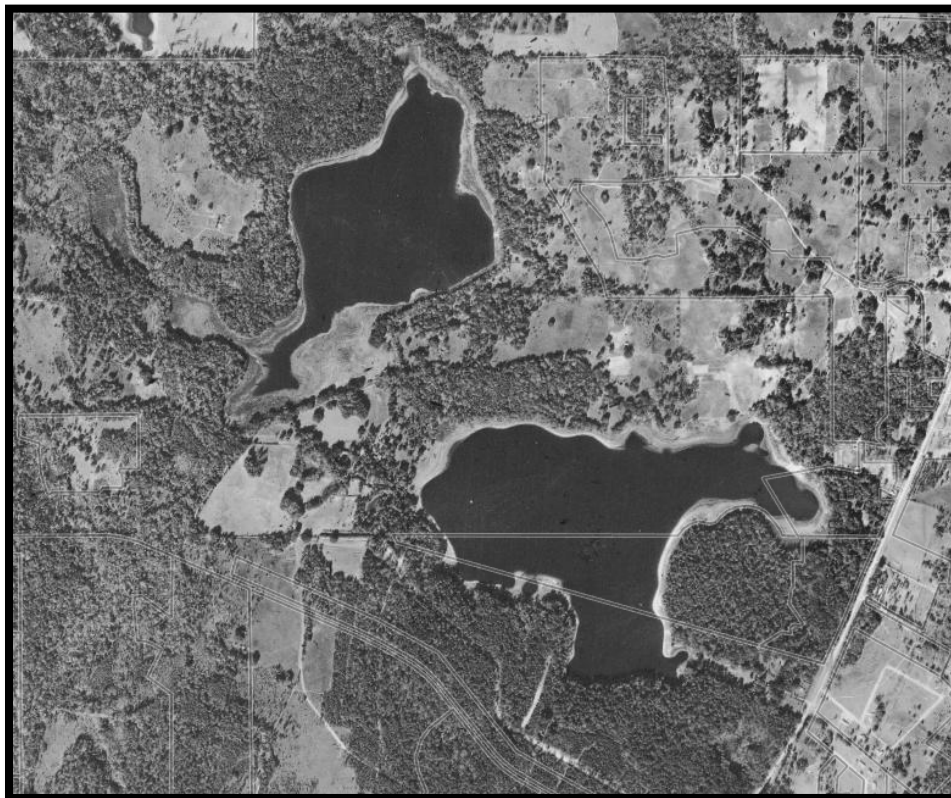
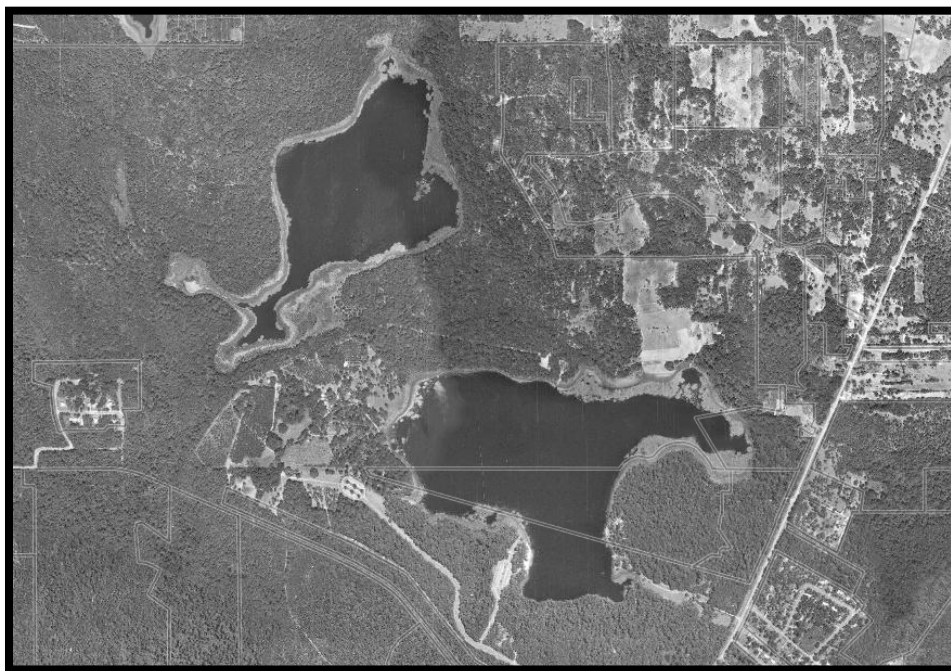
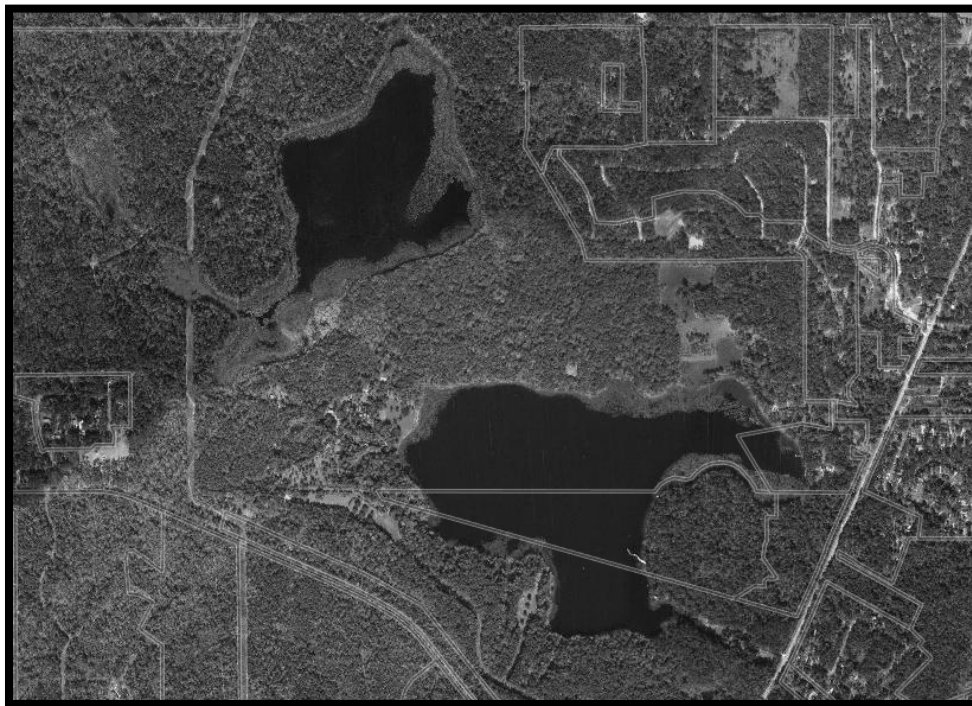
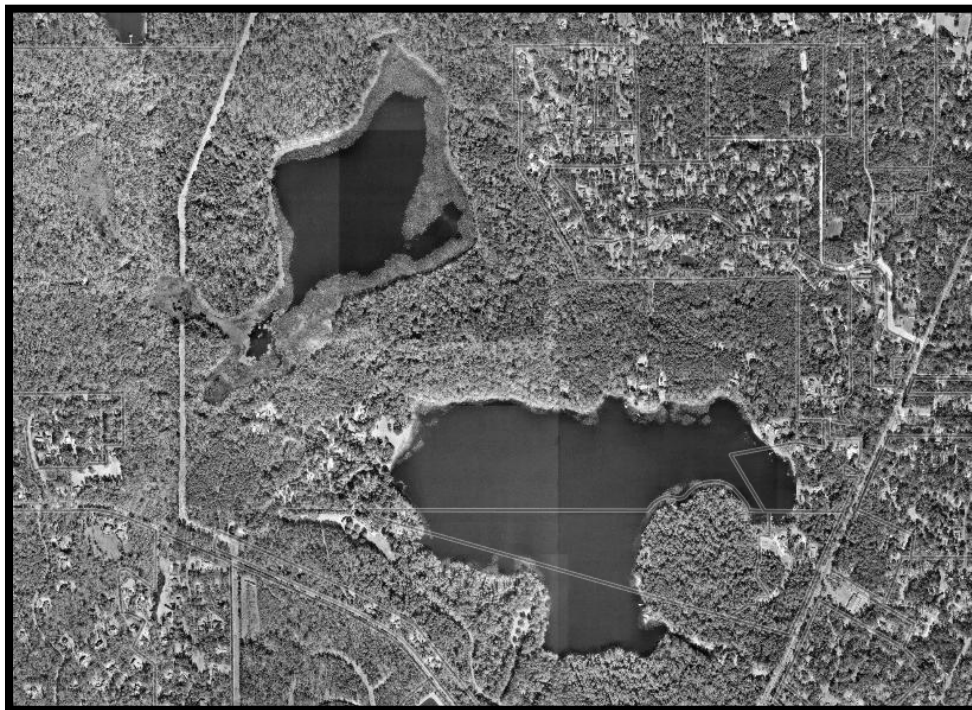
Lake Overstreet is a relatively deep lake for the area, with depths throughout much of the lake greater than 20 ft. **Photo 4-42** through **Photo 4-49** present aerial views of the lake from 1937 through the present. Examination of the aerial photos shows that the lake has generally remained the same over this period of time and, due to the depths, maintains open water throughout much of its area. The only variations seen are in the degree of vegetative cover in the southern portion and the degree of clearing in the land surrounding the lake. Prior to 1970, much of the land surrounding the lake was cleared, especially along the eastern side. After 1970, the surrounding land was reforested, and presently the entire shoreline and a significant buffer around the lake are natural.

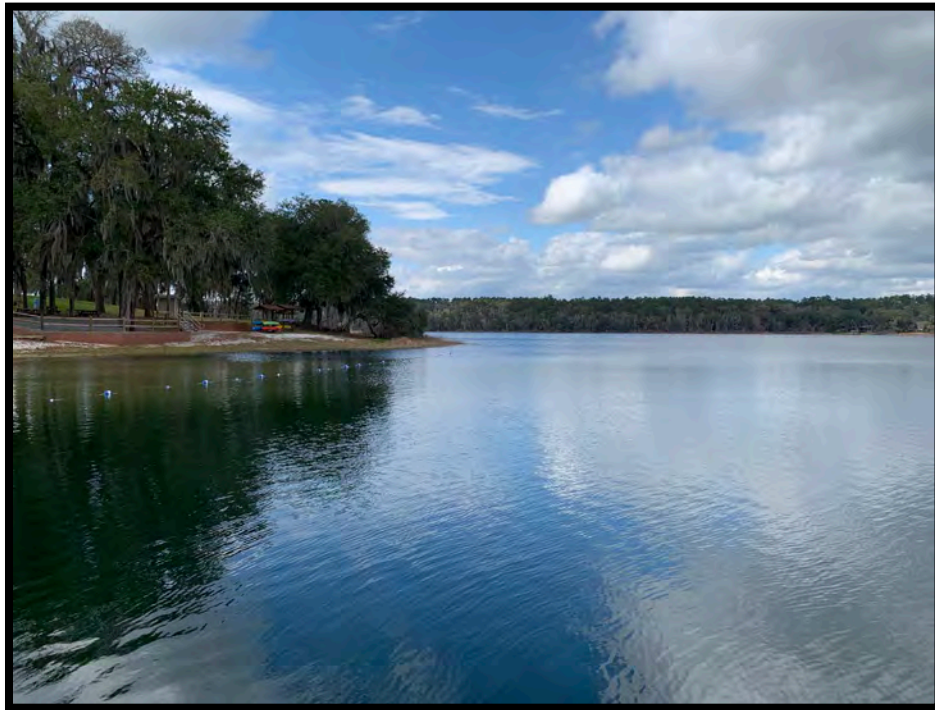
**Photo 4-50: Lake Hall Photo 1**

Lake Hall has been identified as one of the most pristine waterbodies in the area. **Photo 4-50** and **Photo 4-51** were taken from the Maclay Gardens boat dock, located in the southern lobe of the lake looking north. The photos show the open water nature of the lake and the general shoreline conditions.

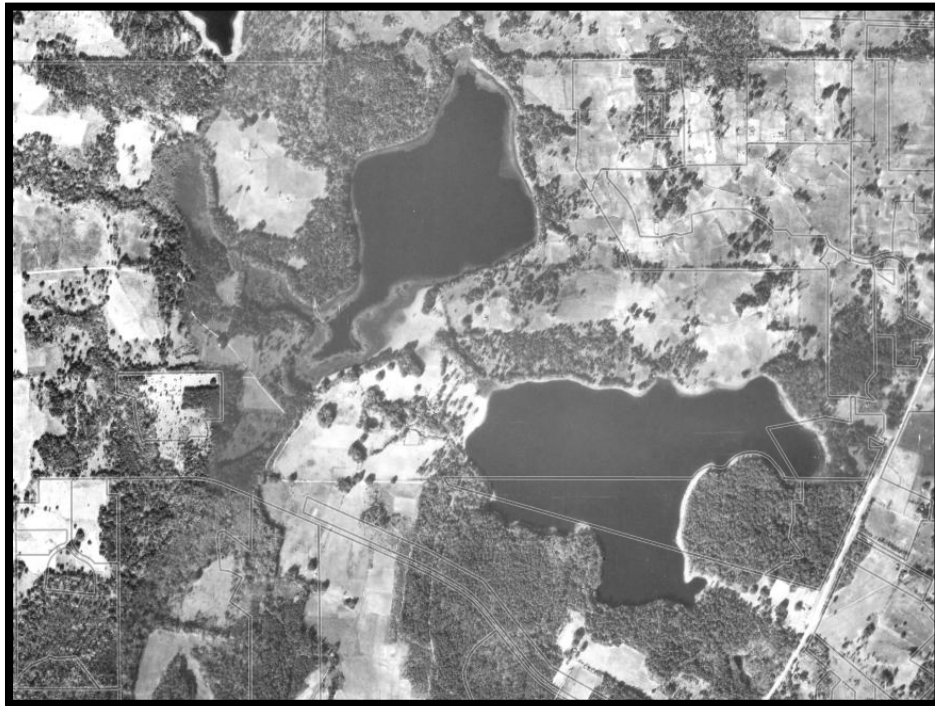
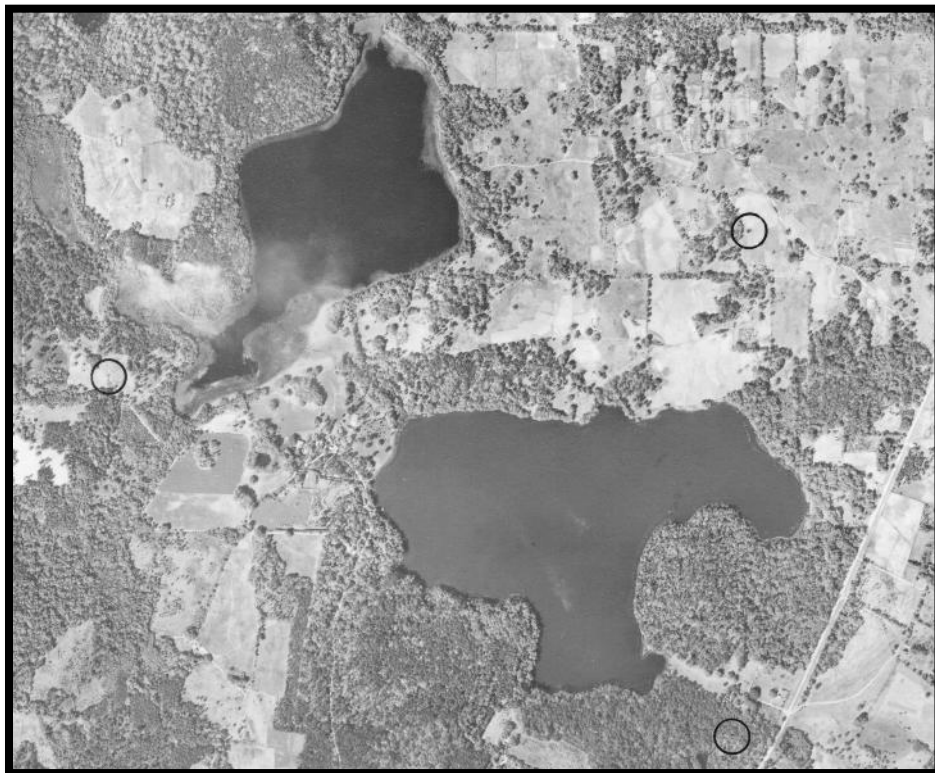
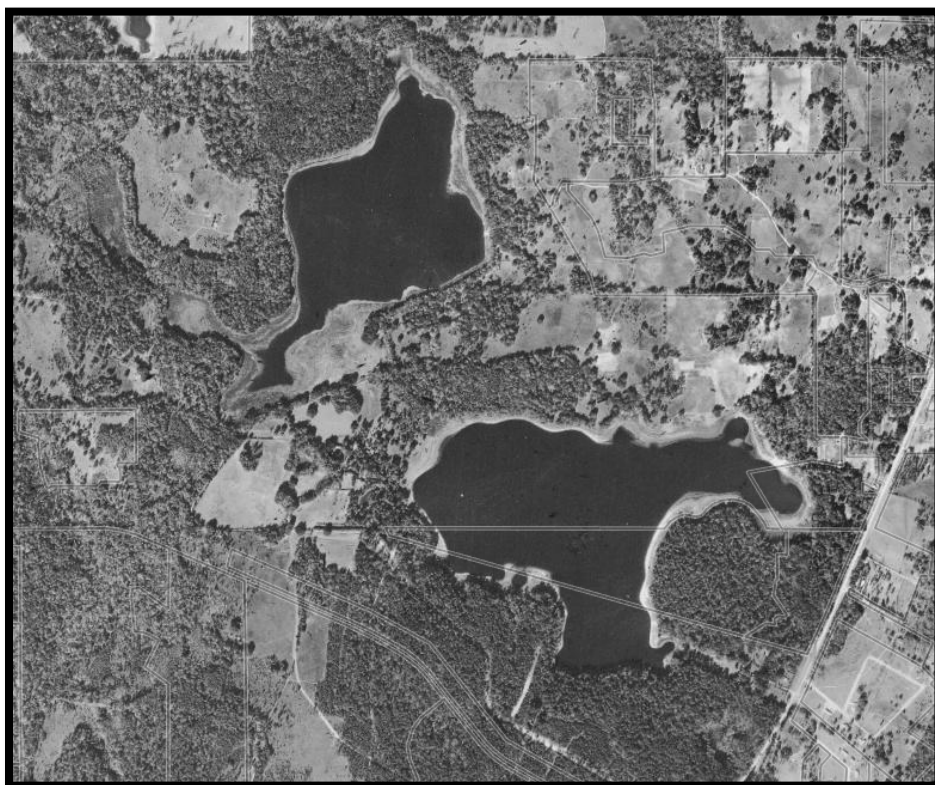
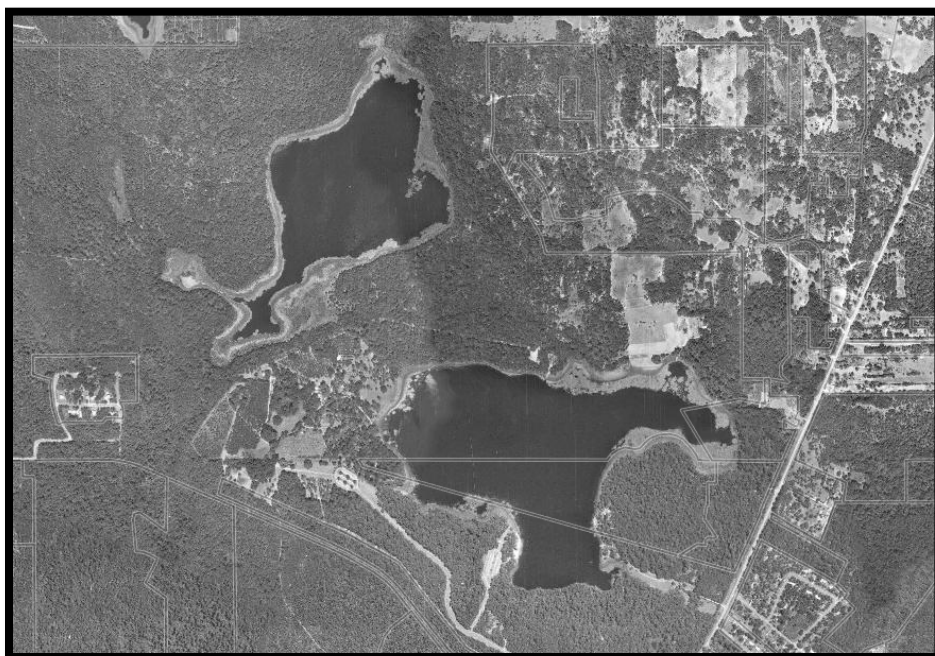
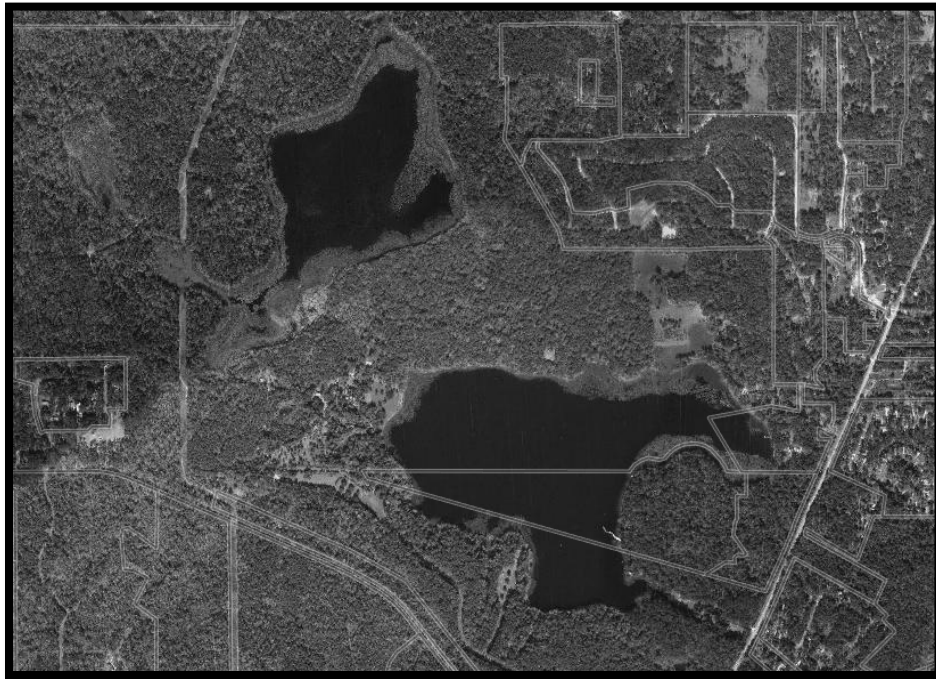
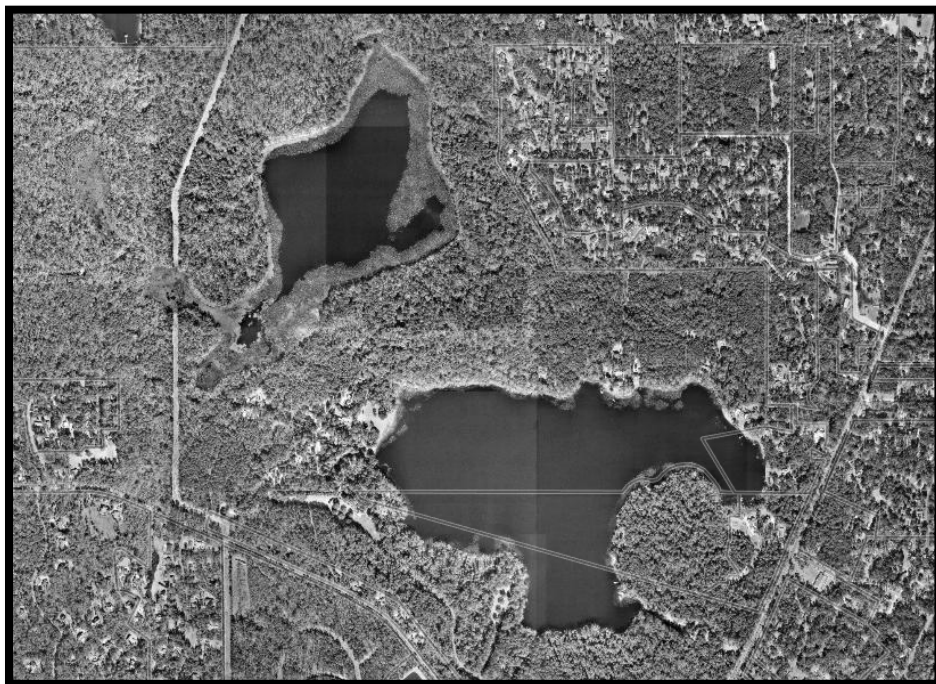
Lake Hall is a deep lake for the area, with maximum depths around 30 ft. **Photo 4-52** through **Photo 4-59** present aerial views of the lake from 1937 through the present. As was seen for Lake Overstreet, the aerial photos show that the lake has generally remained the same over this period of time and, due to the depths, maintains open water throughout much of its area. Prior to 1970, much of the land north of the lake was cleared and was reforested over the years. Lands to the south of the lake have not changed significantly. The residential developments within the closed basin appear over time after around 1970.

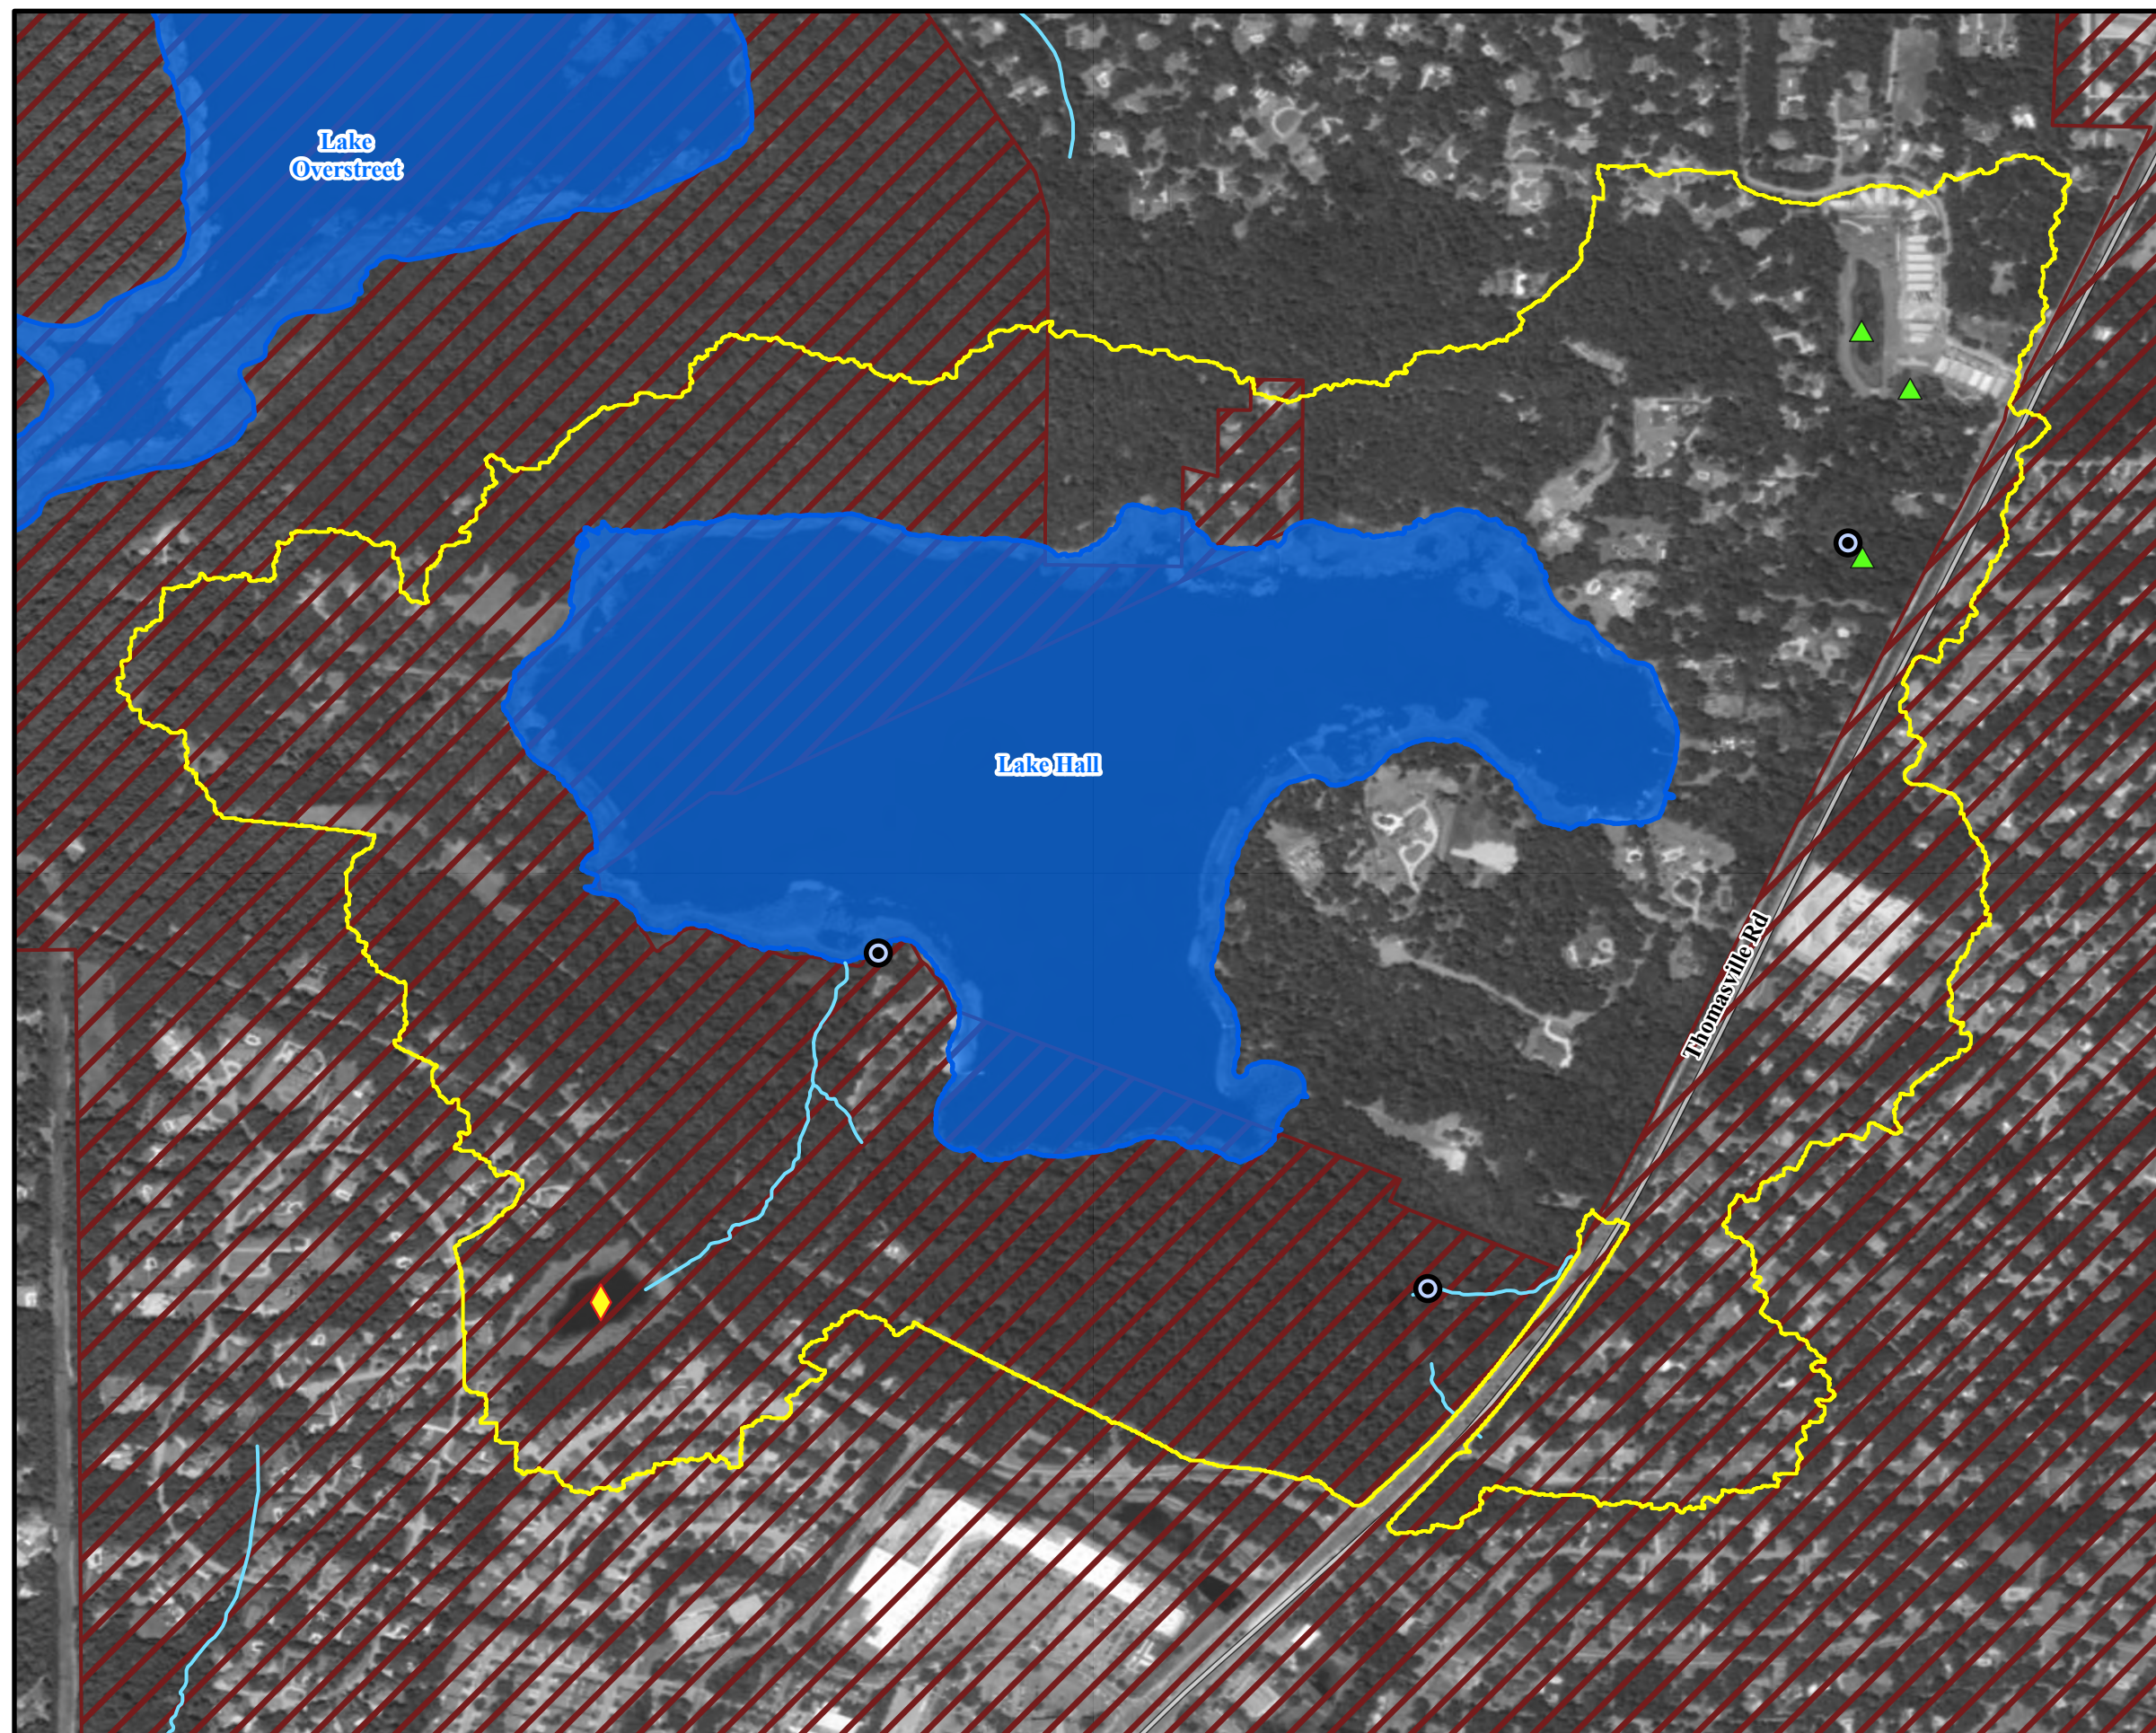
**Figure 4-135** presents a map showing the locations of stormwater treatment facilities throughout the Lake Hall basin. There are relatively few facilities throughout the basin, and these are located within the neighborhoods along Thomasville Road and Maclay Road. The facilities are maintained by the City, Leon County, and Maclay Gardens. No facilities are located within the portion of the basin within neighborhoods east of Thomasville Road.

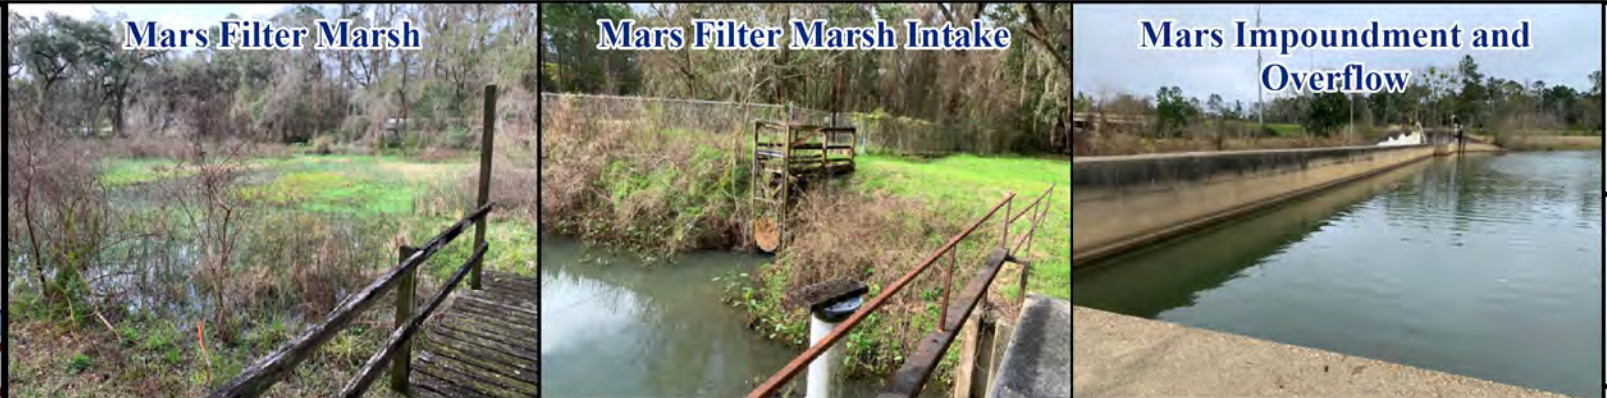
**Figure 4-178:**  
**Lake Jackson - MARS Facility Restoration Study**

Nutrient loading to the southern side of Lake Jackson was identified as a key stressor in **Section 4.11.1.2**. Megginnis Arm is one of the two primary discharges to the southern side of the lake and drains a highly urbanized area. The MARS Facility was constructed to treat runoff into Megginnis Creek. **Figure 4-178** provides an overview of the MARS Facility, including an aerial view of the system components, a diagram outlining the design components, and photos taken in 2021 of the overflow, the filter marsh intake, and a portion of the filter marsh.
